# Manhole Inspection Summary

Manhole # S21G1\_017MH

Insp Date: **4/29/08 12:11 PM**

**Location** Address: **2507 arbuton av**

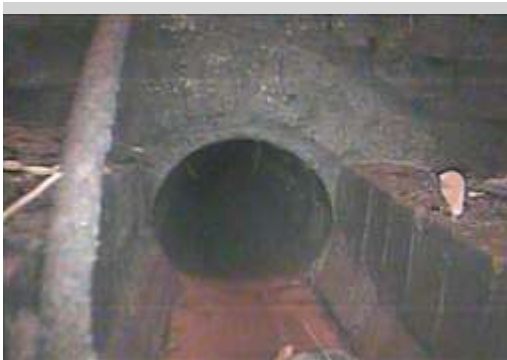
Misc

Channel Debris

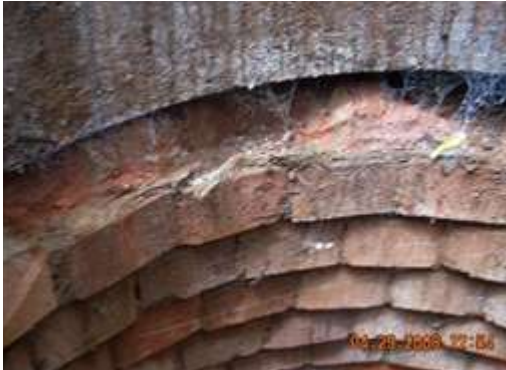
Defect 1

Condition: ☐ Sound ☐ Cracked ☐ Root Intrusion ☐ Loose Brick ☒ **Deteriorated**

deteriorated corbel bricks

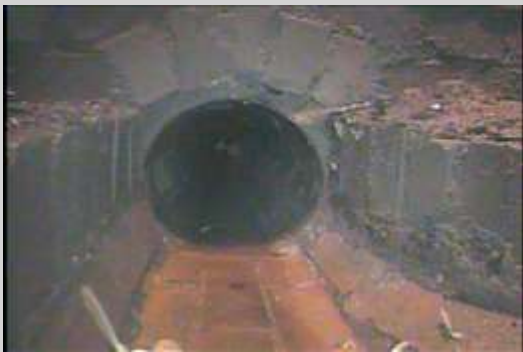
12 O'Clock Outflow

Pipe Height: **8.4** (in.) Rod and Bar (Angled)  
Pipe Material: **Clay** ☐ Pipe Lined  
Invert Depth: **9.95** (ft.) Flow Characteristics: **Slow**  
Deposits: ☒ None ☐ Mud ☐ Sludge ☐ Debris ☐ Grease  
Silt Depth: **0** (in.) Deposits Extent:  
Infiltration: **None** Pipe Seal Cond: **Sound**

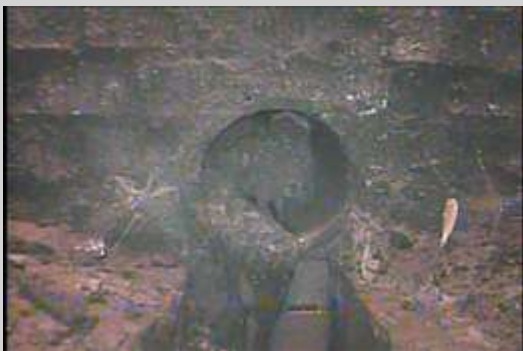
3 O'Clock Inflow

Pipe Height: **6** (in.) Rod and Bar (Angled)  
Pipe Material: **Clay** ☐ Pipe Lined  
Invert Depth: **9.30** (ft.) Flow Characteristics: **Slow**  
Deposits: ☐ None ☐ Mud ☒ Sludge ☒ Debris ☐ Grease  
Silt Depth: **5** (in.) Deposits Extent: **Heavy**  
Infiltration: **None** Pipe Seal Cond: **Roots**

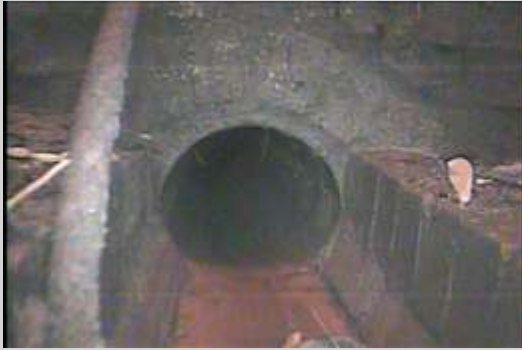
6 O'Clock Inflow

Deposits: ☒ None ☐ Mud ☐ Sludge ☐ Debris ☐ Grease

Infiltration: **None** Pipe Seal Cond: **Sound**
